RESULTS OF THE DAM STATE MONITORING AND SUBSTANTIATION OF CAUSES OF THE TAILINGS POND AREA DEFORMATION

The paper involves both practices and monitoring results of an active tailings pond where concentration plant slurry is accumulated. The research subject is a dam of tailings pond Kryvi Luky belonging to Ordzhonikidze Mining and Processing Plant PJSC.

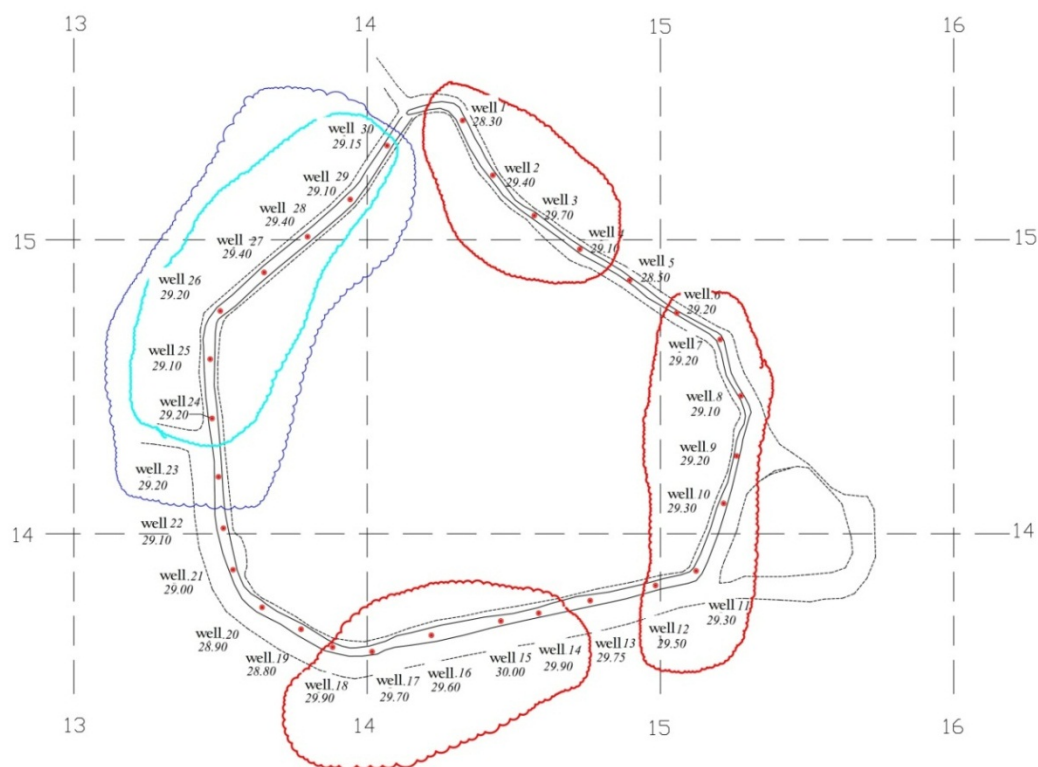
Figure 1 – Arrangement of wells of the geological engineering surveys in 2017

red boundaries are the zones of pile clays; blue boundary is a technogenic laminar filtering zone; and dark blue boundary is a zone of non-homogeneous structure of the dam basis

Geologically, the tailings pond is based upon the non-homogeneous mass of pile heavy clay loam with interlayers and lens of light clay and rare sand inclusions with complex internal structure of dams. In the neighborhood of wells 1–4, and 14–18, a layer of relatively homogeneous pile clays was defined in the basement of a tailings pond. Predominantly, the clay loam was heavy and silty with interlayers and inclusions of light clay. In the context of water extract composition, the soil was very injurious in terms of a sulfate activity degree. Moreover, the soil is of high corrosiveness as for lead coating and aluminium one.

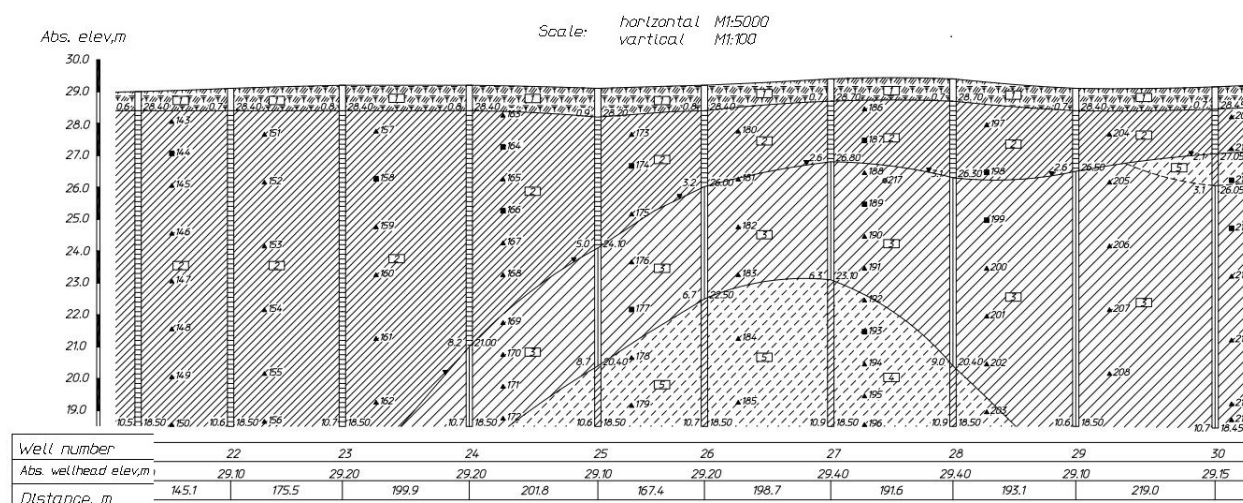
Figure 2 – Engineering and geological section (scheme) (the year of 2017)

During the period of the first engineering and geological surveys (i.e. during 2017), no ground water was available within the studied territory down to the explored depth being 9.8–11.5 m. However, in the neighborhood of wells 24–30, technogenic laminar filtering occurred at 2.1–8.2-m depth. The filtering did not have a constant level; nevertheless, certain watered areas were available (see Fig. 1). Water mass filtration took place through formation of light clay loam and sandy clay. Mass of heavy clay loam and light clay served as an aquifer (Fig. 2). A light sandy clay lay-

er was of rather non-homogeneous structure. Near well 30, sandy loam lens was identified at 2-m depth. Sandy fraction had characteristic predominance within the lens.

Analysis of the tailings pond rock composition made it possible to understand that in the neighborhood of wells 23–30, lens-shaped layer of sandy-loam is spread in the basis of the mass; the layer underlies a light loam stratum. Potentially, such a dam structure is dangerous since it creates conditions for the development of suffusion processes resulting from a filtration crossflow of water mass from the Western section of the tailings pond to its Eastern section. Hence, a non-homogeneous structure zone of the dam basis and technogenic filtration zone where separate watered areas arise are of similar periphery. At the expense of such a non-homogeneous structure of a dam basis, rock consolidation was not achieved.

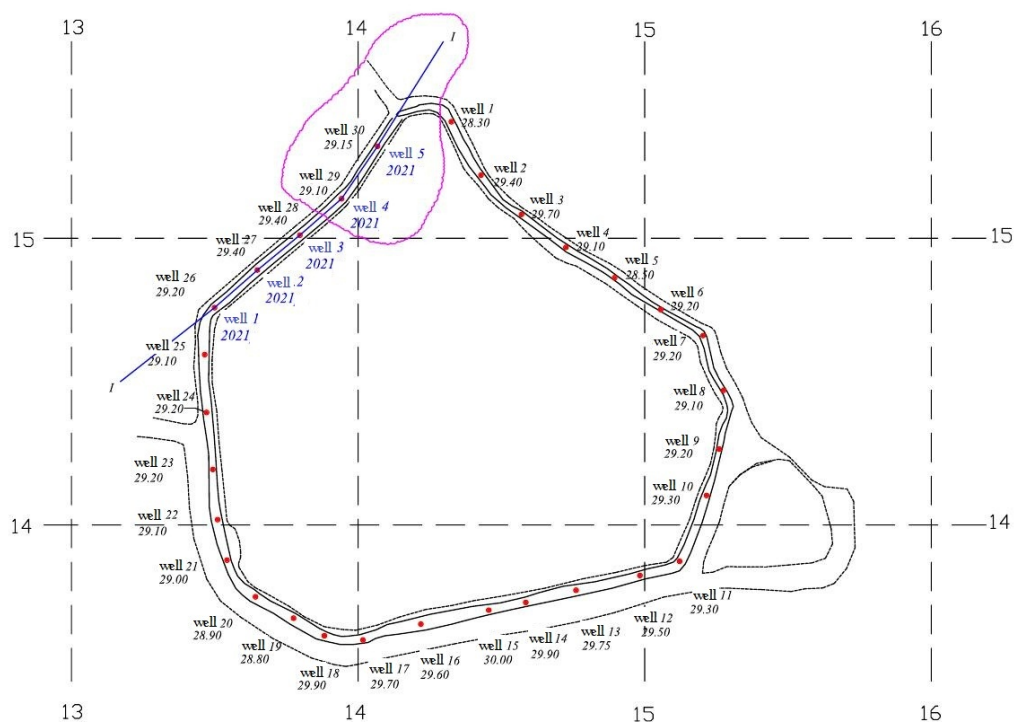
Figure 3 – Arrangement of wells of the engineering and geological surveys in 2021; violet line is a zone where lens of plastic consistency zone increases

The availability of the non-homogeneous mass of pile heavy clay loam with inter-layers and light clay lens provoked formation of laminar filtering zone of technogenic water. Consequently, a decision was made to continue monitoring of the hydraulic structure state. Therefore, the second set of engineering and geological surveys was performed in 2021 within the area differing in dangerous conditions. Five inspection wells were drilled to control a zone of non-homogeneous dam structure as well as a technogenic filtration zone (Fig. 3).

In the neighborhood of 1-3 wells (corresponding to wells 26-28 drilled in 2017 respectively), significant increase in thickness of plastic consistency sandy loam layer was identified.

In the neighborhood of wells 4 and 5 (corresponding to wells 29 and 30 drilled in 2017 respectively), considerable growth in plastic consistency sandy loam lens was seen. The fact is demonstrated by the engineering and geological section (see I-I line).

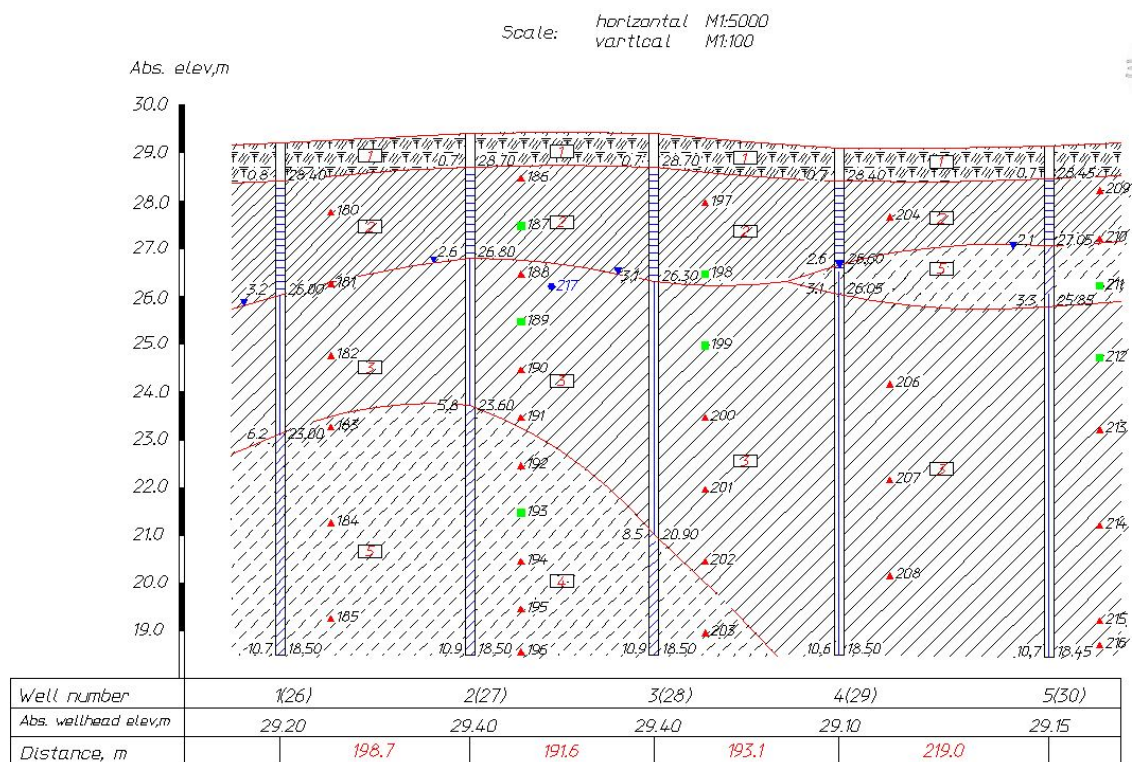
Figure 4 – Engineering and geological section along I-I line (the year of 2021)

Well core processing analysis helped construct stratigraphic columns; in addition, geological section of the dam area was upgraded (Fig. 4).

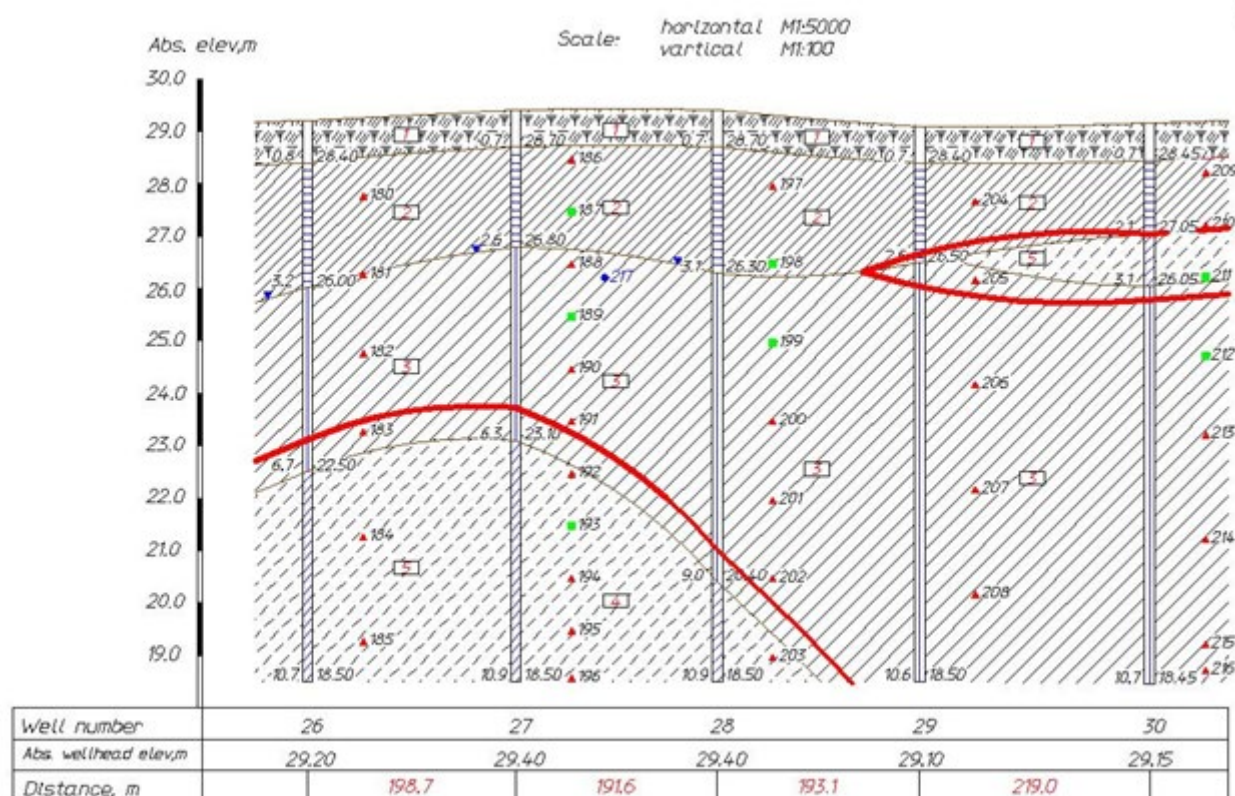
Figure 5 – Comparative arrangement scheme of the engineering and geological elements along the section (years of 2017 and 2021) where red line shows the data for 2021; and brown one shows the data for 2017

In the context of the section, a red line visualizes clearly the increased dimensions and thickness of plastic consistency sandy loam layer; the fact has a negative impact on geomechanical stability of the structure in general.

Comparison of the sections in terms of their coordinates made it possible to see progress of deformation processes in the enclosing rocks. Resulting from suffosion (i.e. technogenic water penetration through the dam), underwashing of rock layers takes place. Hence, the flow removes soluble substances and fine mineral particles from them.

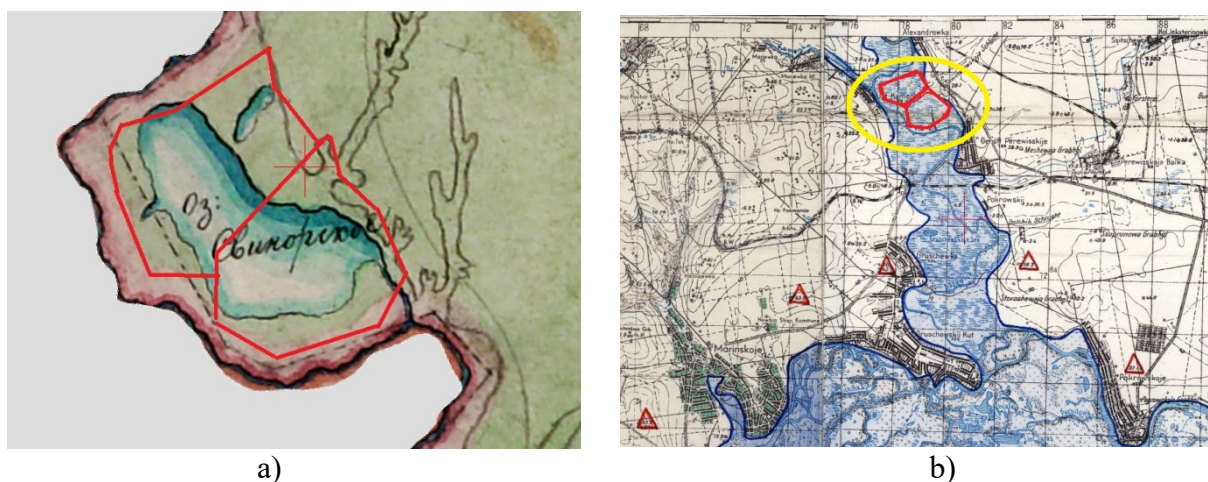
Figure 6 – Excerpt of cartographic materials of the site under study

To provide stability of such rocks, it is required to implement such specific engineering measures as drainage, chemical stabilization, compression, and reinforcement. Use of the integrated approach helps minimize risks, and ensure durability of structures built on such bases. However, determination of the optimum measures should involve detailed analysis of the facility, its structure and basis. Hence, archival data were analyzed which made it possible to identify peculiarities of the terrain and geological mass where the hydraulic structure was built. OldMaps software helped understand that the tailings pond is within a high-risk area where there are specific demands for research and preparation before the hydraulic structure is built. The matter is that the construction was performed on the site of the former lake; map of 1821 designates it as a Svinorekhove Lake (Fig. 6, a).

Later, when Kakhovka reservoir was being built, the territory was flooded during several years; the fact is confirmed by a map of 1953 (Fig. 6, b).

Generally, wetlands shaped on the site of the former lake are of complicated geo-mechanical structure due to availability of water-saturated and loose soils:

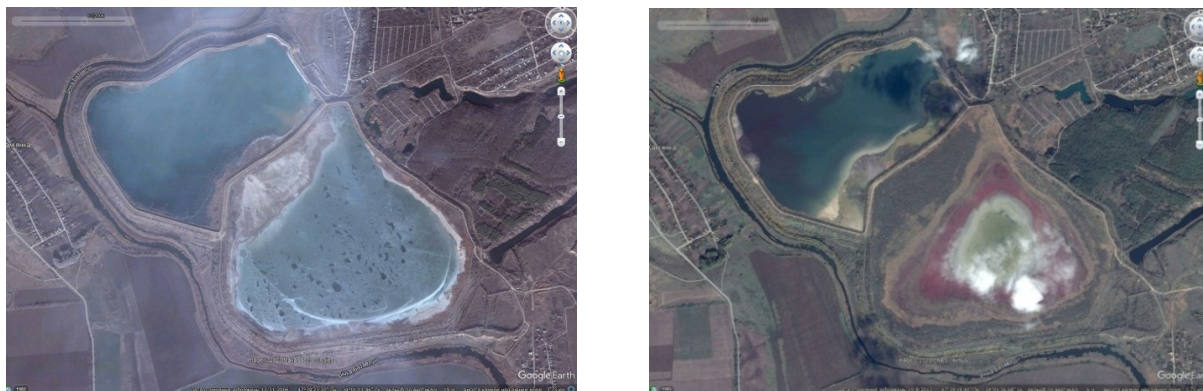
Figure 7 – Excerpt by years of the tailings pond fullness

After the tailings pond construction and during operation period, the dam turned out to be under constant change in soil water saturation resulting from water level variation (i.e. it was either full of water or dry completely). The fact is supported by Google Maps satellite images captured in different years (Fig. 7).
