## RELIABILITY PREDICTION FOR THE RUBBER LINING OPERATING UNDER EXTREME CONDITIONS

<sup>1</sup>Kalhankov Ye.V., <sup>1</sup>Lysytsia M.I., <sup>1</sup>Ahaltsov H.M., <sup>2</sup>Cherniy O.A.

<sup>1</sup>Institute of Geotechnical Mechanics named by N. Poljakov of National Academy of Sciences of Ukraine, <sup>2</sup>Dnipro State Agrarian and Economic University

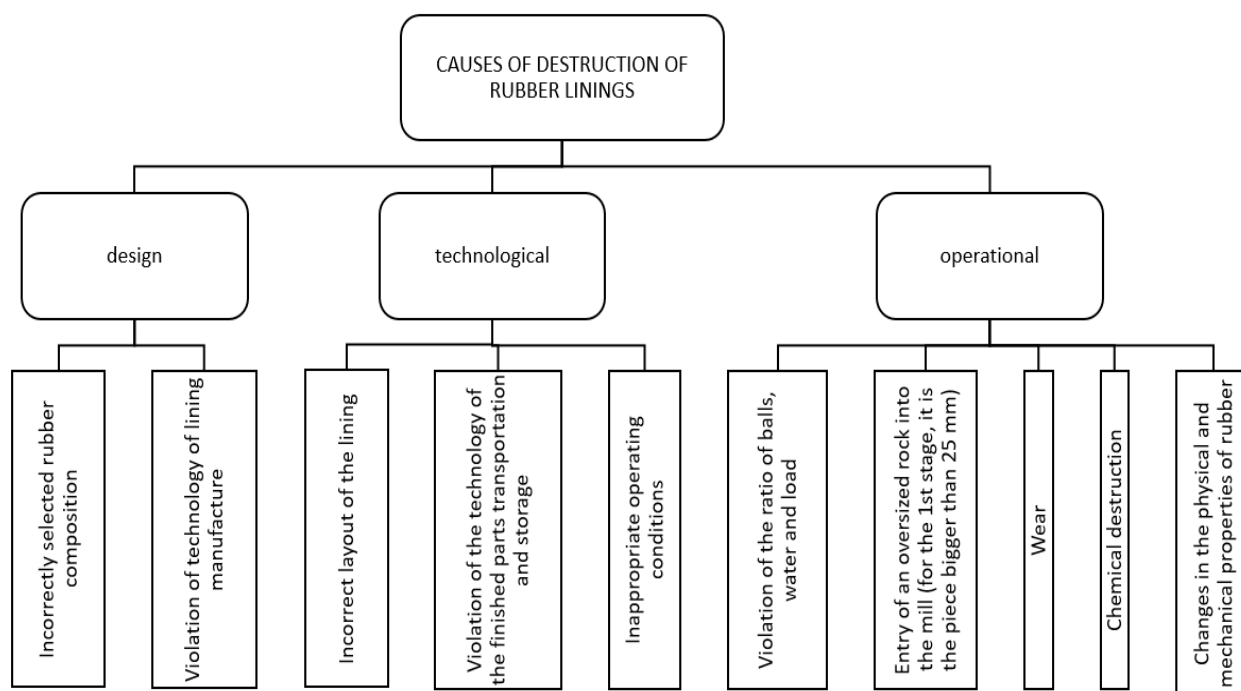
**Methods.** Destruction of rubber linings can be conditionally divided into three groups: design, technological and operational (Fig. 1).

Figure 1 – Causes of destruction of rubber linings

The design causes for the destruction of rubber linings are related to the inconsistency of the original rubber composition with the conditions in which the lining is planned to be used, incorrect construction (geometric shape of the lining plate), and others. According to the observations and studies of the causes of failure of linings, which were carried out at SevGOK (Kryvyi Rih) and Poltava GOK (Poltava), where

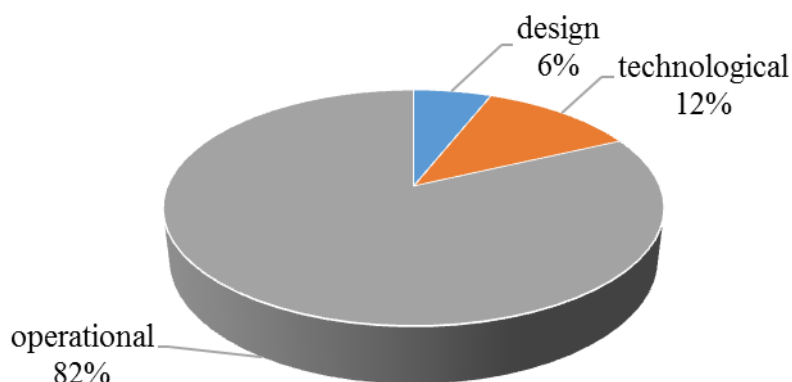
linings produced by the company Valsa GTV (Ukraine, Bila Tserkva) were installed at the first stage of grinding, they make up about 6% (Fig. 2 ).

Figure 2 – Distribution of the causes of destruction of rubber linings

The technological causes are related to the violation of the technology of lining plates manufacturing and the imperfection of this process, incorrect calculation of scheme for the plates laying out and mounting in the drum of the mill. In particular, the technological factor is essentially influenced by the introduction of various modifiers into the rubber composition and their uniform distribution. Technological reasons account for about 12% of destructions (Fig. 2).

Operational destruction occurs as a result of violation of the rules of operation of the lining and the mill as a whole, violation of the rules of repair and commissioning procedures, as well as storage and transportation of the lining plates. Operational destructions make up almost 82% (Fig. 2).

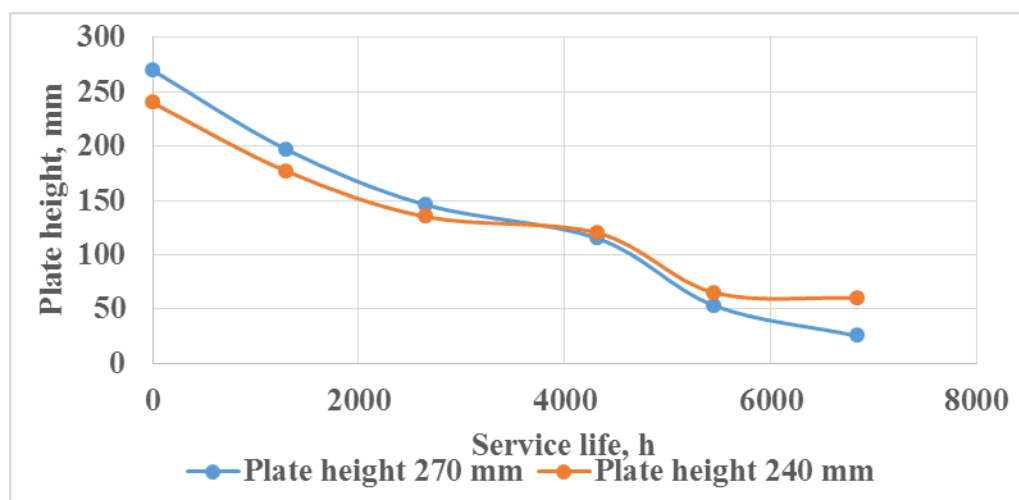
Since 2013, SevGOK has been testing linings in mills of the first stage of grinding with ball diameter of 100 mm. Here, the produced by the company Valsa GTV (Ukraine, Bila Tserkva) lining of the “H-wave plate” type, with increased height, that is the height of the lining is 270 mm and 240 mm, is used. The plates were arranged as follows: 270 mm plates for first 3 rows from the loading grating, and 240 mm - for the rest. The wear of plates is shown in Fig. 3 and Fig. 4.

Having analyzed the Fig. 3, it can be concluded that when lining plates are worn to a height of 115-130 mm, destructive changes begin to occur in them, that is, the action of load spread throughout the thickness of the plate and it begins to intensively change its rigidity-dissipative properties, its upper layer is intensively worn, and the

next layers quickly become more stiffer and later wear out as well. Due to the increased stiffness, the rubber aggregates are broken off more easily (as less energy is spent on their breaking off) and wear occurs faster.

Figure 3 – Wear of lining plates

Therefore, the predicted reliability of the rubber lining is 8305 hours, which almost coincides with the reliability of the lining which worked in the drum mill MIIP 3.6×4.0 with balls Ø 100 mm having the service life of 6800 hours, according to Fig. 3. Today, the average service life of rubber lining in drum mills of the first grinding stage is 8,000 hours [1], which almost coincides with the predicted reliability.

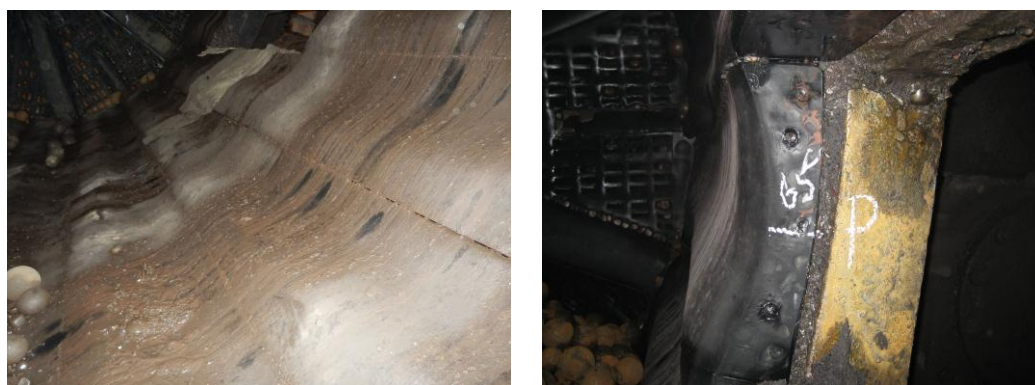
Figure 4 – Wear of linings and measurement of plate height during inspection

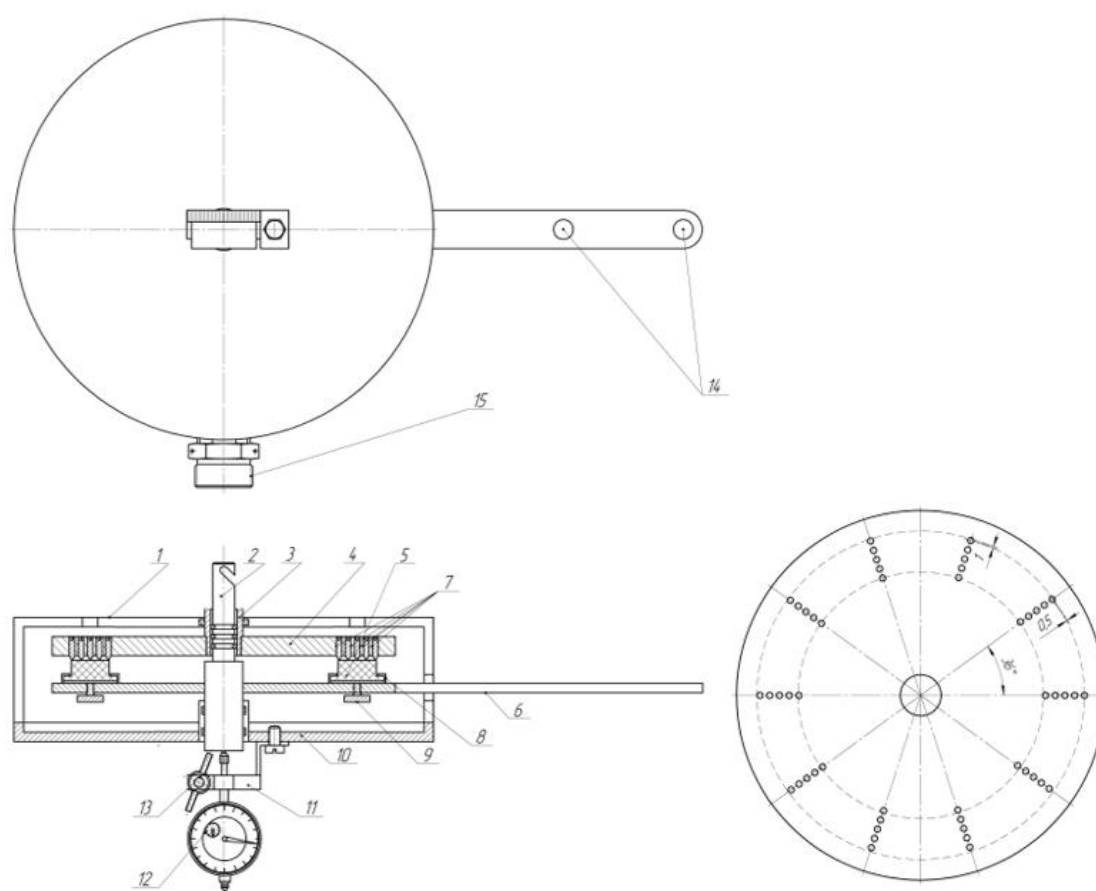
The proposed method for determining the energy of the rubber destruction is implemented as follows. A rubber sample is prepared, its worn surface is leveled and the remains of rock and ore dirt are removed. The sample is installed in the modernized МИ-2 friction machine (Fig. 5) in the plant housing 1. The pre-weighed sample of rubber in the form of a circle 5 is installed on the drive disk 4, indenters 7 are installed in the fixed indenter housings 8 and are fixed on the loading bar 6, which is connected to the loading shaft 2.

1 – plant housing, 2 – loading shaft, 3 – drive sleeve, 4 – drive disc, 5 – rubber sample, 6 – loading bar, 7 – indenters, 8 – indenter housing, 9 – adjusting screw, 10 – cover, 11 – bracket, 12 – clock-type indicator, 13 – latch, 14 – holes for attaching counterweights and dynamometer, 15 – fitting for the pneumatic system connection.

Figure 5 – The modernized MI-2 friction machine

Depth of the scratch made by the indenter is adjusted by screwing the adjustment screw 9. Cover 10 is installed on the shaft 2 and fixed. Shaft 2 is loaded with a load, and then a clock-type indicator 12 is installed in its end with a tension of 1.5...2 turns

and is fixed with a latch 13 on the bracket 11. Dynamometer and weights of a certain size are installed in the holes 14 on the loading bar.

Further, electric motor of the plant is activated, and the drive sleeve 3 with the disk 4 and the rubber sample 5 rotates, the degree of linear wear is fixed by indicator 12 and, when the required value is reached, the plant is stopped simultaneously with simultaneous activation of the pneumatic system of the plant, and the wear products are sucked out through the fitting 15. After the test, the sample is dismantled and weighed, particles of the wear products are collected and counted by using optical devices.
